**WETLANDS DELINEATION**  
**HANCOCK COUNTY PORT AND HARBOR COMMISSION**  
**STENNIS INTERNATIONAL AIRPORT – SITE 1**  
**KILN, MISSISSIPPI**  
**NS Project # 13531.001.023**

Report Date: August 7, 2018

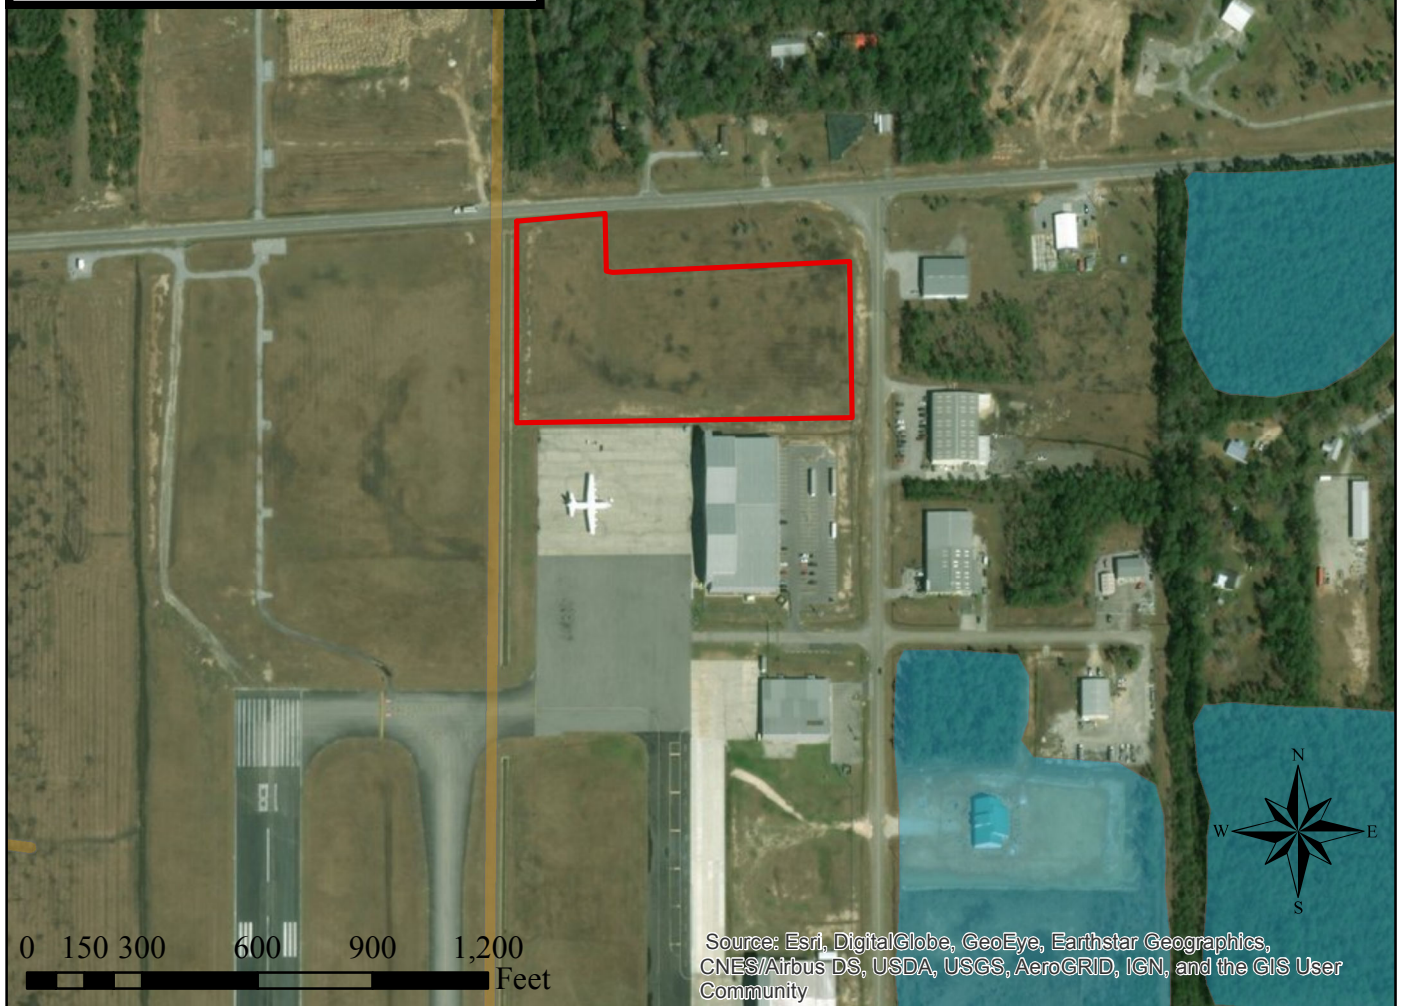
## NRCS Soil Survey

The NRCS soil survey depicts five soil series on the site:

- 1) Atmore silt loam – 0-2% slopes; found in depressions, terraces, and flats on divides; poorly drained; considered hydric
- 2) Beauregard silt loam – 0-1% slopes; found along coastal plains; moderately well drained; considered non-hydric
- 3) Poarch fine sandy loam – prime farmland soil; 2-5% slopes; found along ridges; well drained; considered non-hydric
- 4) Saucier fine sandy loam – prime farmland soil; 2-5% slopes; found along fluviomarine terraces; moderately well drained, considered non-hydric
- 5) Sulfaquepts – 0-5% slopes; found along crests and shoulders; poorly drained; considered hydric

Of the five soil series mapped within Site 1, two are considered hydric, and three are considered non-hydric. Two soil series are considered prime farmland soil. The wetland data point was taken within the Beauregard silt loam series. Additional data points were not taken within the mapped boundaries of the remaining four soil series due to the relative homogeneity of upland and wetland site features.

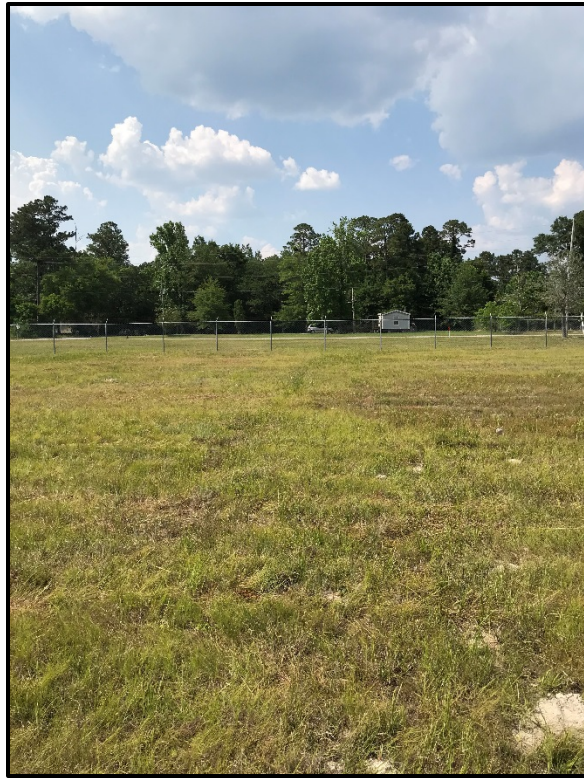
Photograph of Site 1, facing east

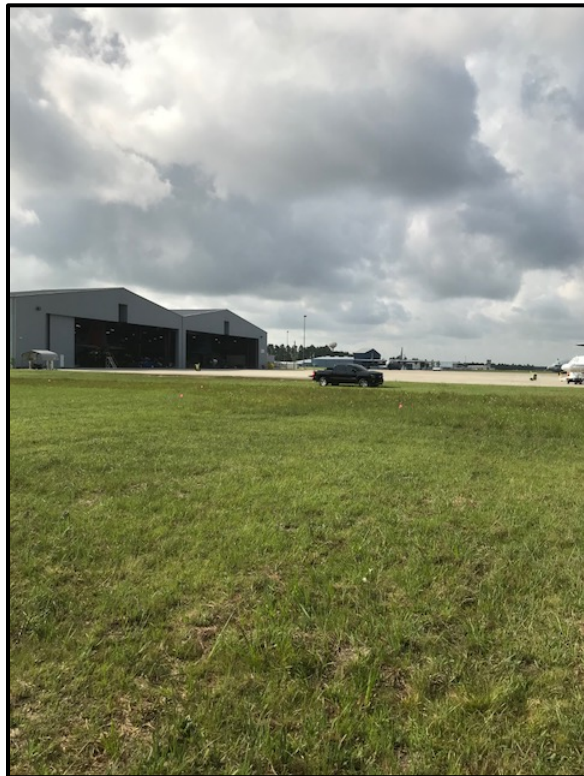
Photograph of Site 1, facing south

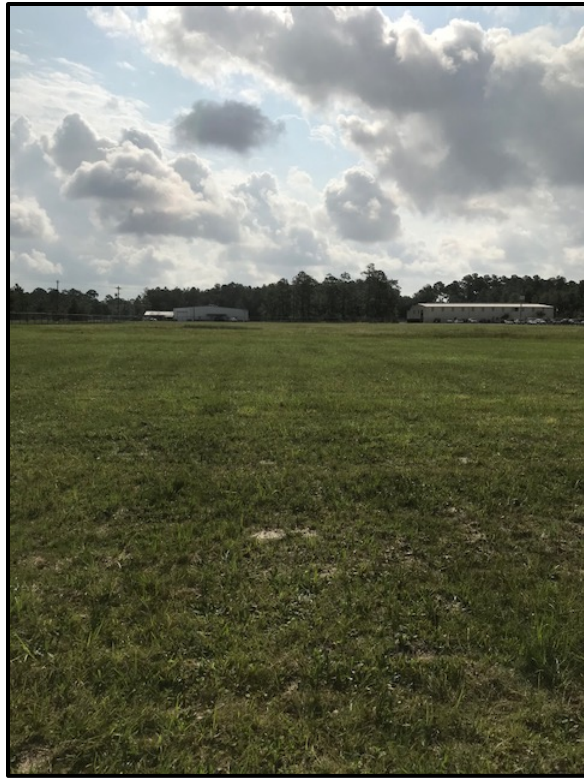
Photograph of Site 1, facing east from the western edge

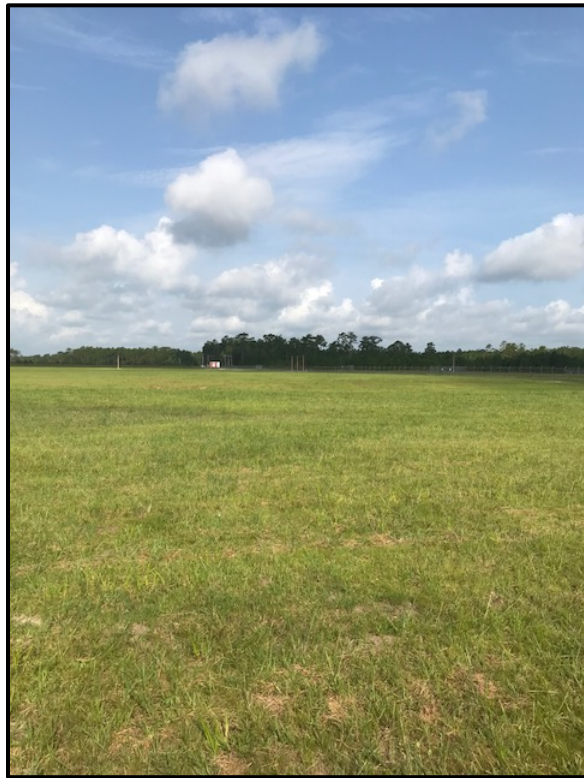
Photograph of Site 1, facing west from the eastern edge

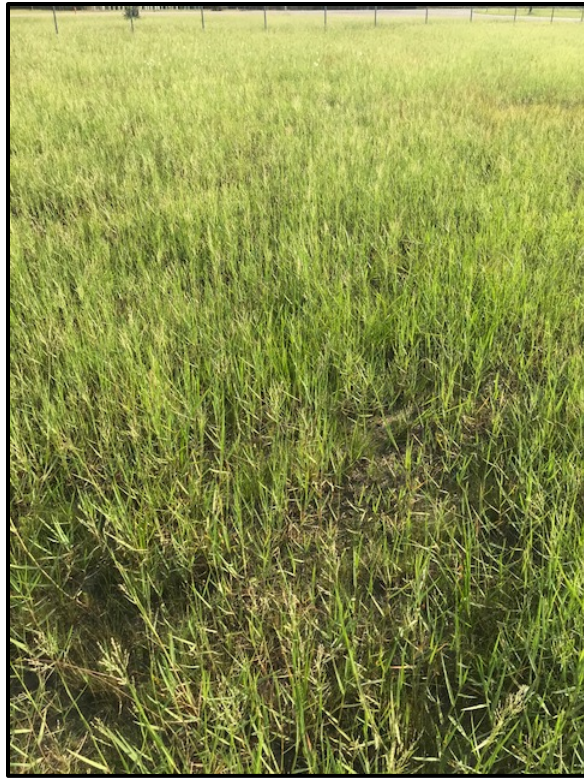
| 1. Panicum repens                      85                  Y                  FACW | | | | <b>Definitions of Four Vegetation Strata:</b> | |
| 2. Rhynchospora cephalantha                  10                  N                  OBL | | | | <b>Tree</b> – Woody plants, excluding vines, 3 in. (7.6 cm) or more in diameter at breast height (DBH), regardless of height. | |
| 3. Hypericum brachyphyllum                  5                  N                  FACW | | | | <b>Sapling/Shrub</b> – Woody plants, excluding vines, less than 3 in. DBH and greater than 3.28 ft (1 m) tall. | |

Vegetation at SP1

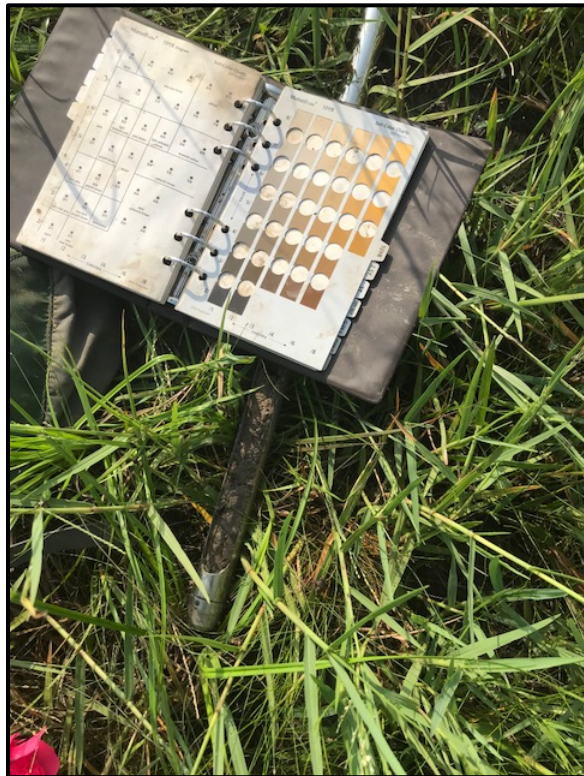
| Depth<br>(inches) | Matrix | | Redox Features | | | | Texture | Remarks |
|---|---|---|---|---|---|---|---|---|
| 0-1 | 10YR 3/2 | 100 | | | | | loam | |
| 1-7 | 10YR 3/2 | 98 | 5YR 4/6 | 1 | C | PL | loam | Fe |
| 1-7 | 10YR 3/2 | 98 | 10YR 2/1 | 1 | C | M | loam | Mn |
| 7-12 | 10YR 4/2 | 85 | 7.5YR 2.5/1 | 15 | C | M | loam | Mn |

Soil profile at SP1

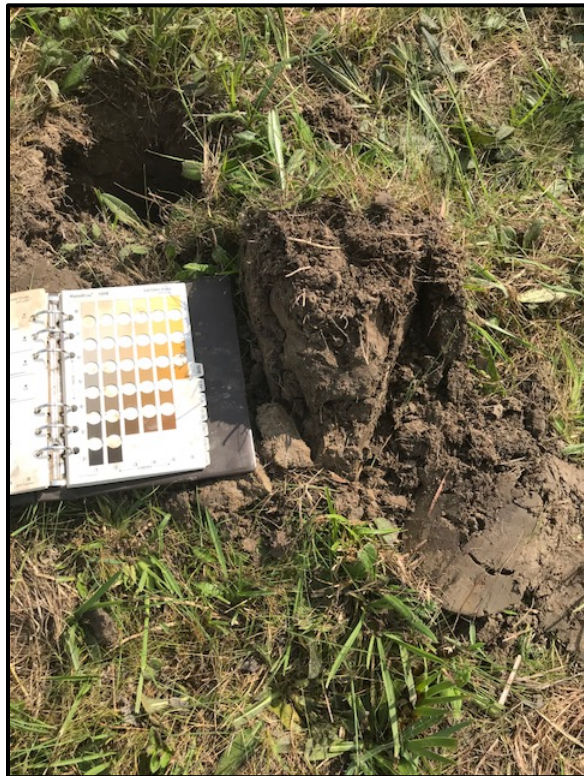
| Depth<br>(inches) | Matrix | | Redox Features | | | | Texture | Remarks |
|---|---|---|---|---|---|---|---|---|
| 1-4 | 7.5YR 4/2 | 99 | 7.5YR 4/6 | 1 | C | M | loam | |
| 4-8 | 7.5YR 4/3 | 99 | 5YR 3/4 | 1 | C | M | loam | Fe |
| 8-12 | 7.5YR 5/2 | 98 | 7.5YR 5/6 | 2 | C | M | loam | Fe |

Soil profile at SP2
